Contract #: 04-0120F4Cty: SF/ALA Rte: 80 PM: 13.2/13.9File #: 1.28**WELDING INSPECTION REPORT****Resident Engineer:** Casey, William**Address:** 333 Burma Road**City:** Oakland, CA 94607**Report No:** WIR-030066**Date Inspected:** 21-Sep-2013**Project Name:** SAS Superstructure**OSM Arrival Time:** 700**Prime Contractor:** American Bridge/Fluor Enterprises, a JV**OSM Departure Time:** 1200**Contractor:** American Bridge/Fluor Enterprises, a JV**Location:** Job Site**CWI Name:** Scott Kortum**CWI Present:** Yes No**Inspected CWI report:** Yes No N/A**Rod Oven in Use:** Yes No N/A**Electrode to specification:** Yes No N/A**Weld Procedures Followed:** Yes No N/A**Qualified Welders:** Yes No N/A**Verified Joint Fit-up:** Yes No N/A**Approved Drawings:** Yes No N/A**Approved WPS:** Yes No N/A**Delayed / Cancelled:** Yes No N/A**Bridge No:** 34-0006**Component:** SAS Tower**Summary of Items Observed:**

WELDING INSPECTION REPORT

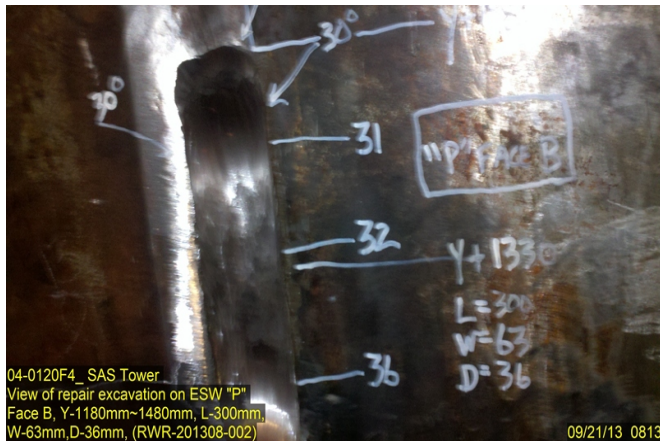
ESW Repair Excavation

RWR-201308-002

ESW N-043, Location "P"-Face B:

The QA Inspector observed ABF welder Donald Plumb (WID-0891) performing excavation to verify indications observed during Ultrasonic Testing with pulse/echo & pitch/catch. Mr. Plumb was performing the excavation using an air carbon arc gouging and a grinder. This repair is being performed from Face B due to a planar indication that was observed & removed on Face A at this Y location. Mr. Plumb was instructed by ABF QC Inspector Scott Kortum to notify him when indications are visible to allow QC/QA time to inspect the excavation. The repair location was noted as:

Weld excavated at: D=25mm- No indications observed.

Weld excavated at: D=36mm- No indications observed.

Excavation Length: (Y-1180mm~1480mm) L=300mm

After grinding to bright metal the QC Inspector performed Magnetic Particle Testing (MT) of the final excavation. The QC Inspector stated the excavation appears to be free of discontinuities and he would complete ABF daily inspection report and magnetic particle testing report to detail the findings. The QA Inspector also performed an

MT verification of the final excavation. See TL-6028 for additional details on items inspected on this date. Mr. Plumb was later observed setting up the Miller ProHeat 35 induction blankets at the repair location in preparation for SMAW of the repair excavation.

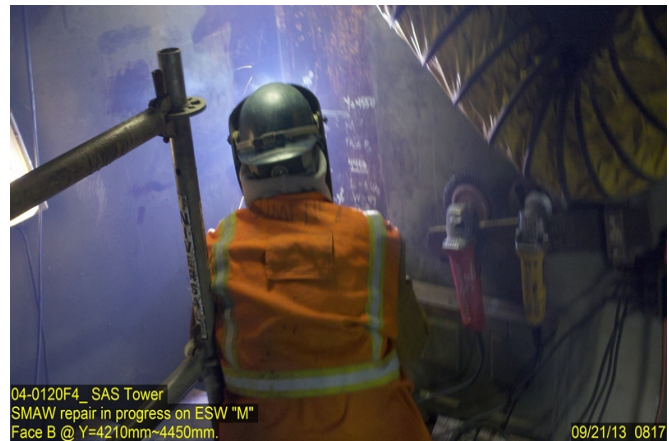
ESW Repair Excavation Welding

RWR-201308-009

ESW W-042, Location "M"-Face B:

The QA Inspector observed ABF welder Mike Jimenez (WID-4671) performing Shield Metal Arc Welding (SMAW) on the repair excavation of Electroslag Weld (ESW) "M" Face B @ Original Y-4400mm. ABF QC Inspector Scott Kortum performed welding parameters verifications at random intervals throughout the shift.

Repair excavation (Y=-4210mm~4450mm) L=340mm, W-47mm, D-54mm.

Prior to welding, Mr. Jimenez was observed preheating the weld to over 300° Fahrenheit using the Miller ProHeat 35 with heat induction blankets and a propylene torch. The welder was using 4.0mm diameter electrode (E7018-1 HR4) per ABF Welding Procedure Specification (WPS) ABF-WPS-D15-1000-Repair Rev.3. The welding process in use was the Shielded Metal Arc Welding process (SMAW). The QA Inspector observed the welding amps were at 178 and preheat was verified with a temperature indicator to be 300°F. The welding observed appeared to be in compliance with the WPS noted above.
